An early 19th-century summerhouse
in Attingham Park, Shropshire:
an interim excavation report

Nigel Baker
October 2018
(2nd edition May 2019)

SUMMARY

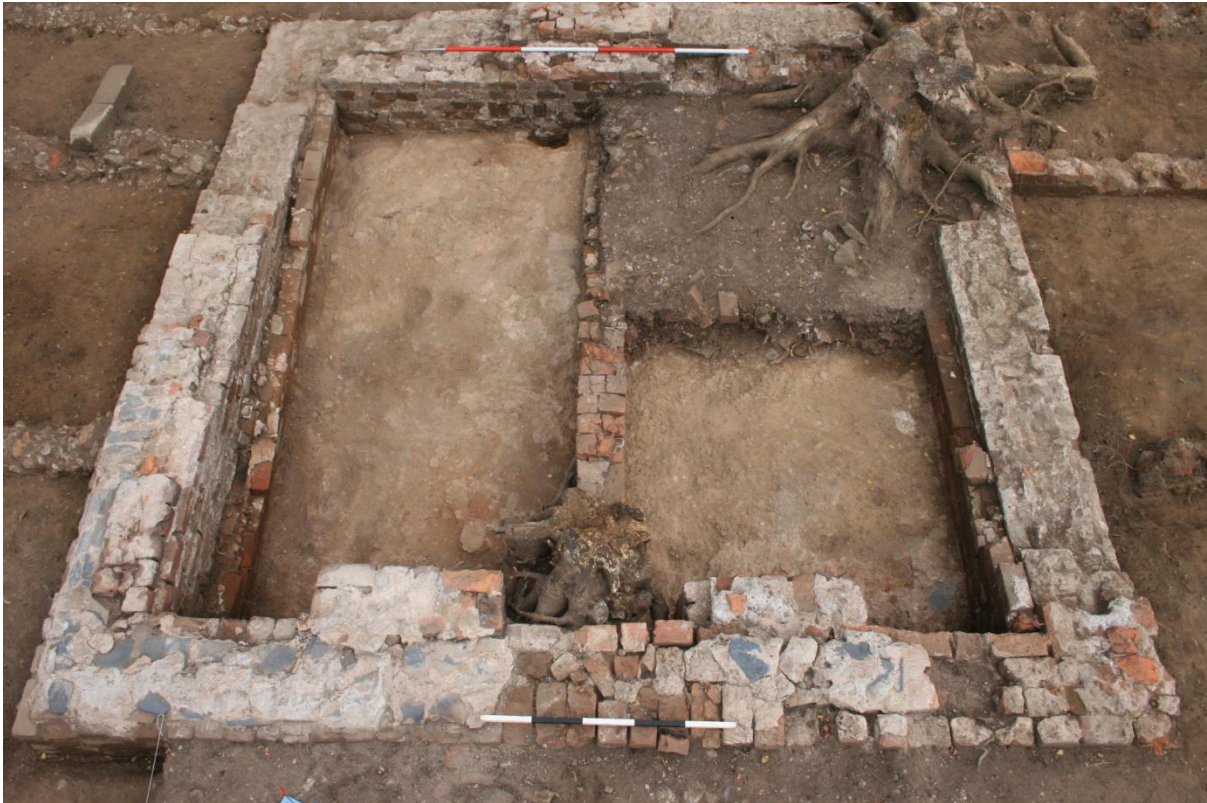
3. Final excavated view, looking south, of the square building

The core of the building and the first structure known to have been built on the site is a brick building 4.8m east-west and 5.05m north-south (roughly 16ft square) externally, with walls varying from 0.46m to 0.52m thick, consisting of four courses of brick laid parallel, using English Bond, bonded with a buff lime mortar. Much of the uppermost surviving surface of the east end of the north wall (333) and the outer 20cms of the north end of the east wall (335) are covered in slates set in a bed of mortar. These are interpreted as levelling-up at the base of stone cladding to the external wall surfaces, a technique applied throughout Attingham's Georgian buildings (with thanks to Graham Sherman for this observation). There is a further patch of this material surviving at the west end of the north wall, leaving a central splayed gap in the position of the doorway. The latter is marked on the inside of the north wall by a pair of rectangular clasp buttress foundations, contemporary with the main fabric; these may have been the base for a pair of engaged columns or pilasters framing the doorway in the room above.

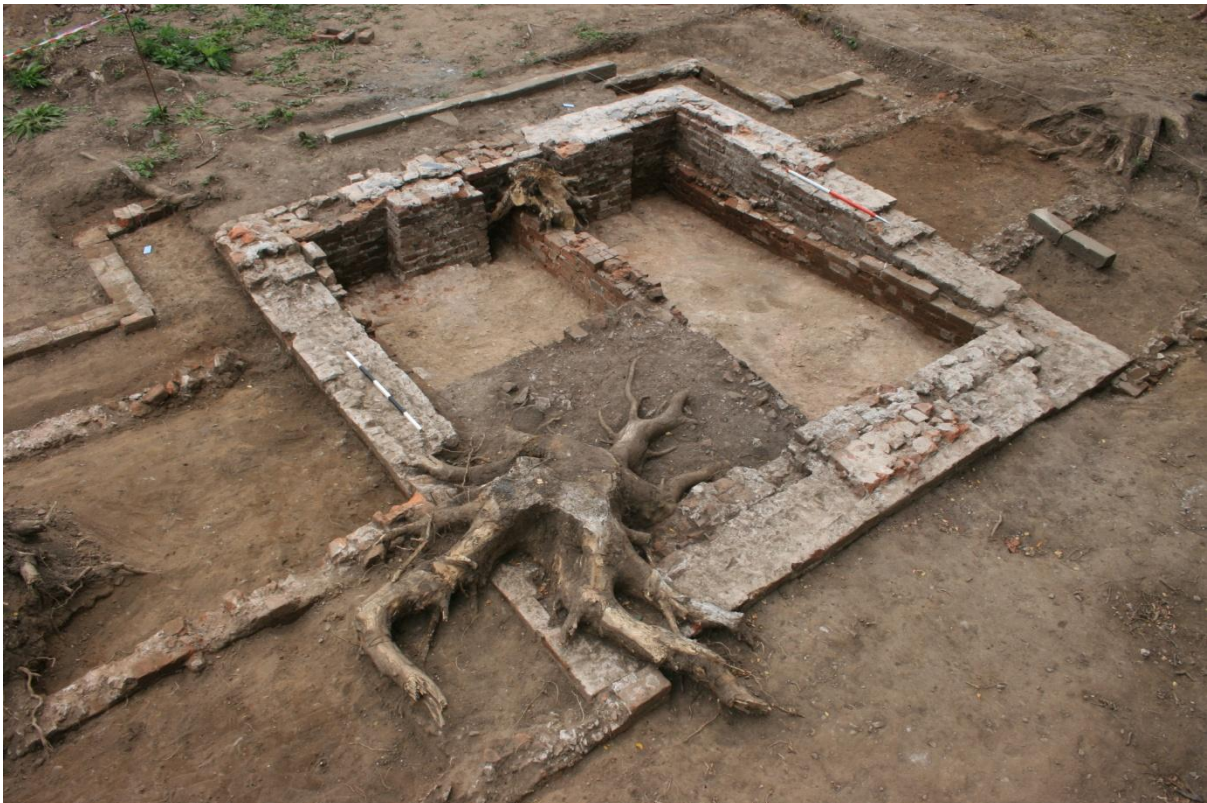
4. Final excavated view of the square building, looking NE

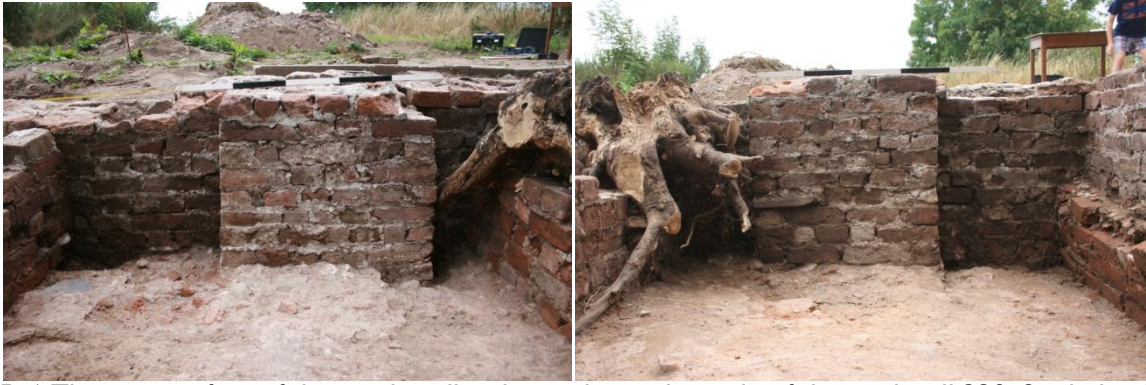
5, 6 The interior face of the north wall – shots taken either side of the axial wall 338. Single-brick joist-supporting walls 339 and 340 can be seen extreme left and extreme right

Within these four thick walls, four further brick walls were added in a single construction episode. Along the interior faces of the west and east main walls, less substantial, one-brick thick, walls were added (339 and 340); the latter was found partially collapsed into the demolition rubble filling the interior. An additional wall (338) two bricks (9 inches) thick was built down the centre-line of the building. These were interpreted as the supports for the east-west joists of a suspended wooden floor, making sense of the deeper deposits within the interior, which were seen to be filling the former sub-floor space. These support walls were however built at the same time as a fourth wall (337) lining the inside of the south wall; much more substantial than the other walls jointed into it, it cannot be fully explained as a floor support. This question is discussed further below. This added wall was plain, apart from a short lintel-like course of headers on their side, coincident with a void (unexplored in the excavation) observed in the mortar surface (309) covering the interior of the square building; these may relate to an underlying drain.

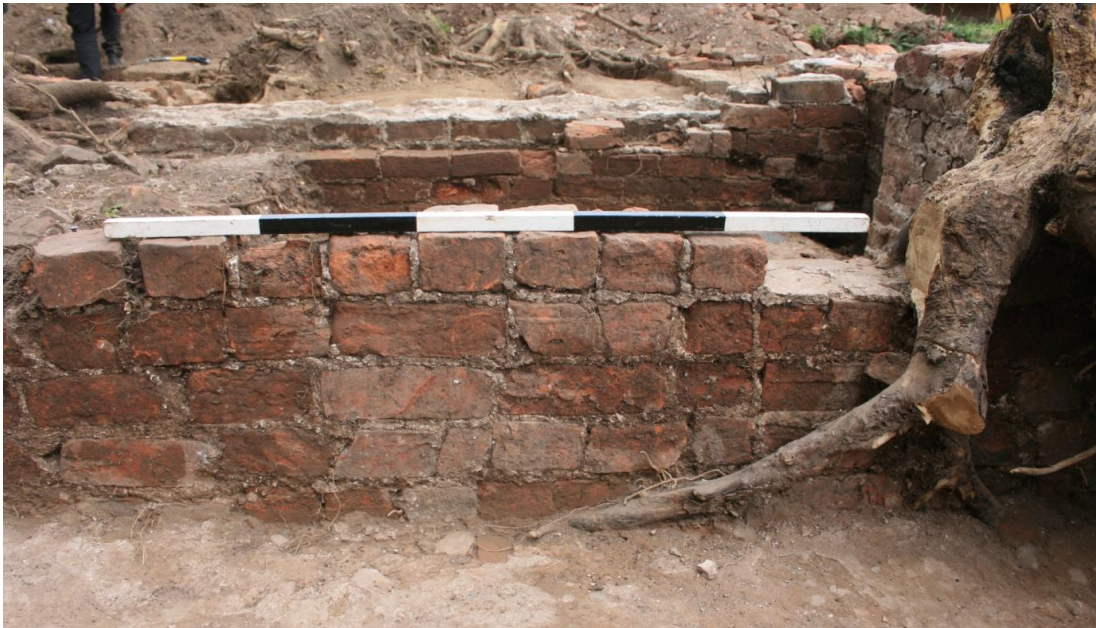
7. The axial 'spine wall' 338, looking west

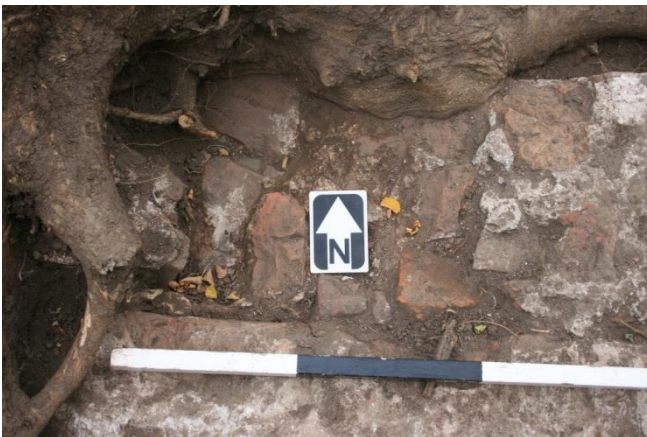
8. The west end of the 'inner' south wall 337 showing diagonal brickwork (? of corner fireplace) visible between tree roots

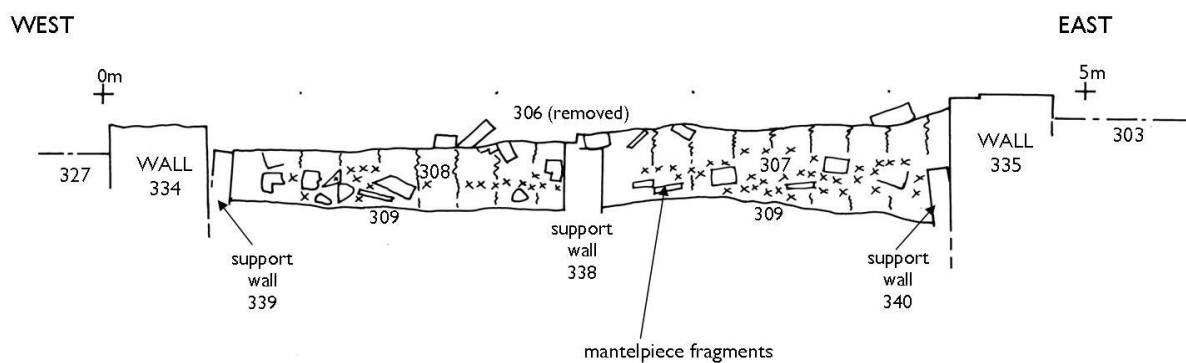
10. Main east-west section across the square building (looking north)

The original depression in the field surface, picked up by LiDAR and defined by the machine-stripping was, following the exposure of the tops of the supporting walls 338-340, revealed to be a former sub-floor space largely filled with a mixture of soil and demolition rubble. The topmost rubble-filled soil (306) was a more rubble-filled version of the medium grey-brown sandy topsoil (301) characteristic of the whole site. Excavation below the wall tops was divided into four quadrants to provide an east-west section and profile, and to give some control over the distribution of artefacts from within the building: NW quadrant (context 308); NE (310); SE (307); the SW quadrant was left unexcavated below this level. The sequence in each quadrant – and in each half of the building, either side of the dividing support wall 338 – was very similar, with increasing amounts of demolition material with depth. Brick rubble with pieces and fragments of mortar was increasingly supplemented by substantial sheets of thick (up to c.4cms) wall- and/or ceiling-plaster with the impressions of laths on the reverse side; some of this material occurred in c. 30cm-wide sheets.

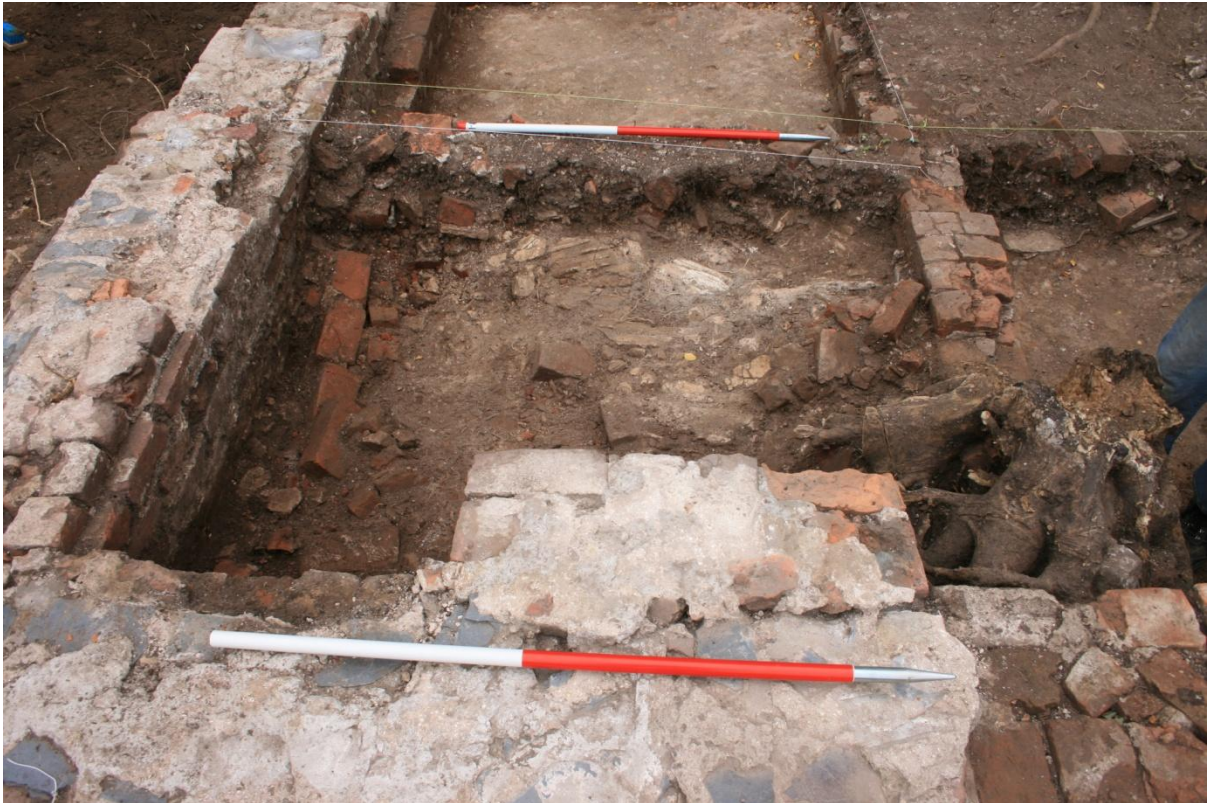
11. A later stage in the excavation of the NE quadrant (310) showing sheets of lath-backed plaster and the collapsed top of joist-supporting wall 335 (left)

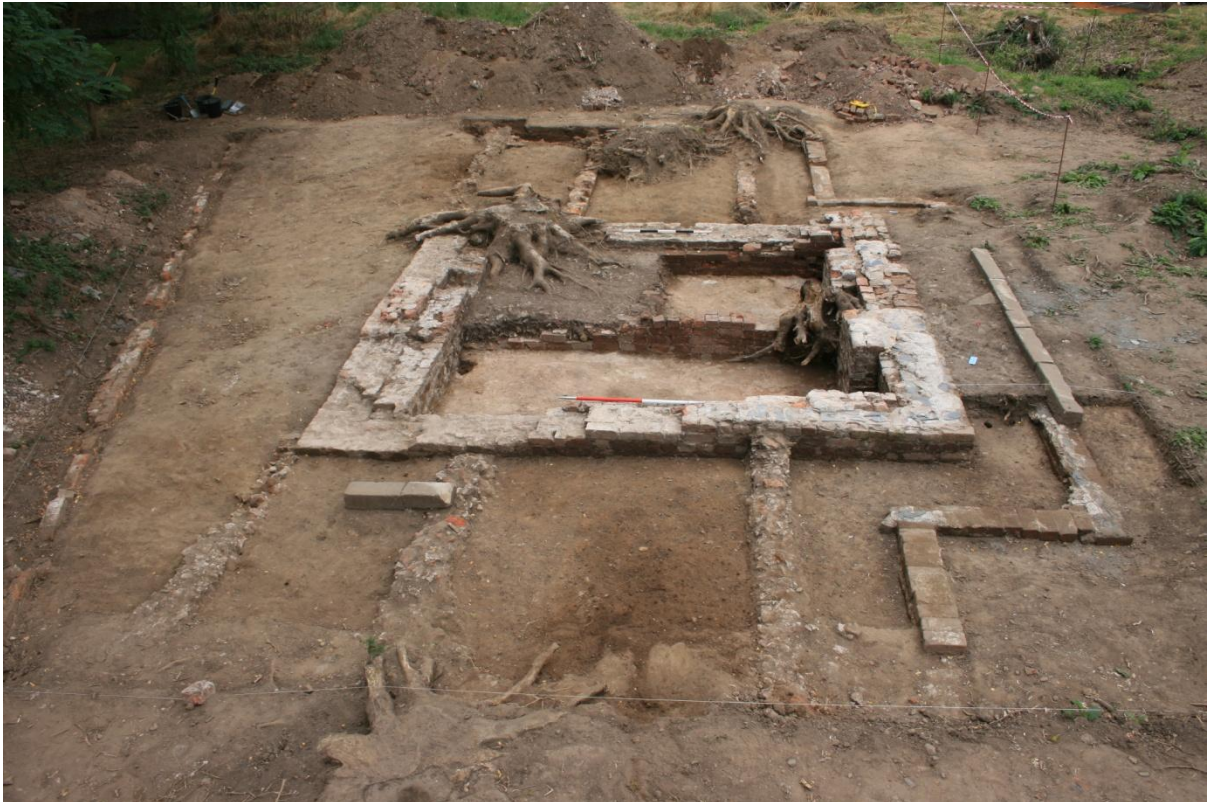
14. General view, looking west, of the building at its maximum extent with the robber trenches and surviving footings of the east wing (foreground) and the west wing (background). Note the enclosure wall 342 at a divergent angle on the left (south)

The square building described above was flanked on the north, west and east sides by a series of further, less substantial, brick walls, nine inches (two bricks) thick. On the north side, the north wall (330) survived up to a level a little below that of the main walls of the square building and in places was capped with slate pieces, suggestive of levelling-up immediately below a change in fabric. This wall extended across the whole north frontage of the building, its central section projecting northwards by 0.7m where it enclosed the square building, continuing c.4m east and west of the square building. Return walls were found at the west end (331) and east end (332), the latter only glimpsed in a sondage extended from the north-east corner of the excavation to locate it. The west wall (331) retained some intact brickwork (at the level investigated – more may have survived at greater depth) only at its south-west corner, most of the remainder of the brickwork having been displaced by tree roots.

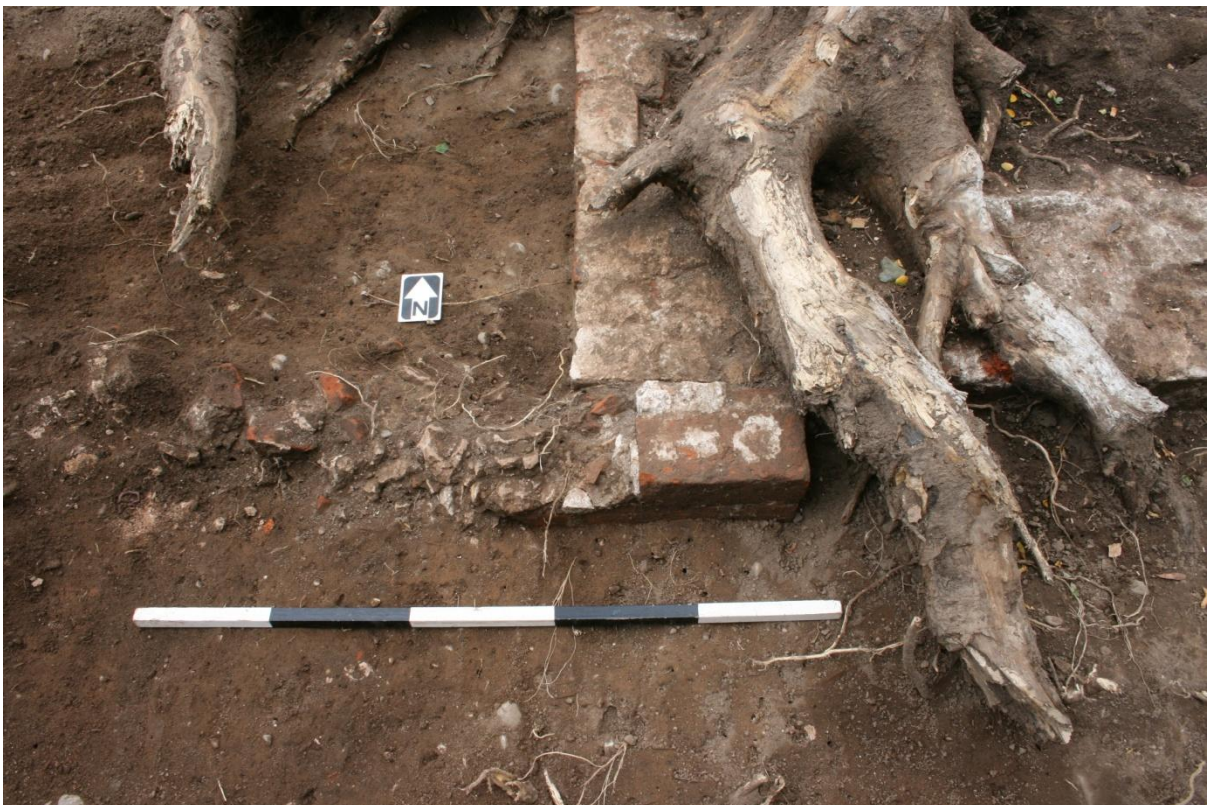
16. Detail of the surviving brickwork at the east end of the wall 324 robber-trench butted against the corner of the square building

The south wall (324) of the west wing was mostly seen and recorded only as a rubble-filled robber trench, brickwork surviving at its junction with the west wall (331) and – crucially – at its junction with the main walls (334/336) of the square building. This showed that the wall was butted up to, and later than, the walls of the square building, partly wrapped around its corner, presumably for extra support. Exactly the same relationship was recorded where fragmentary surviving brickwork of the south wall of the east wing (314) butted against the south-east corner of the square building. In short, in a second phase (perhaps a second phase of construction rather than a second phase of use) the primary

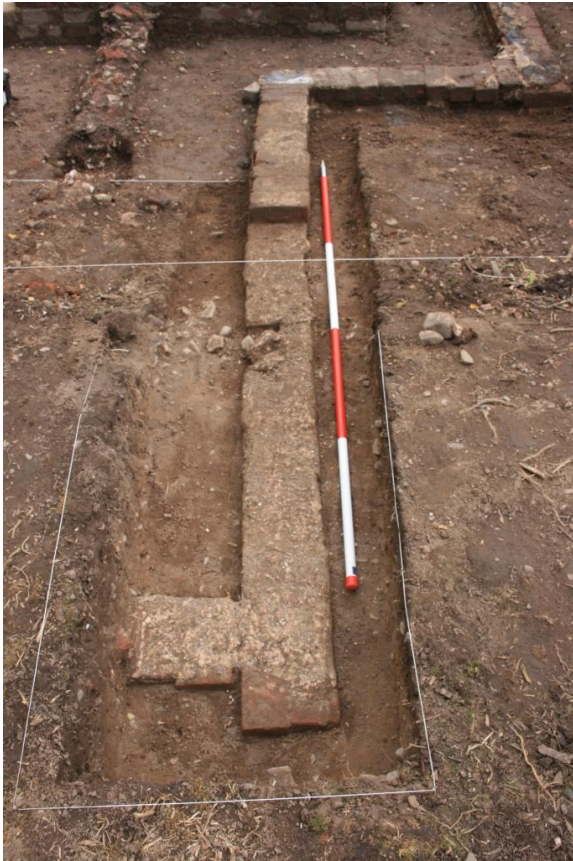
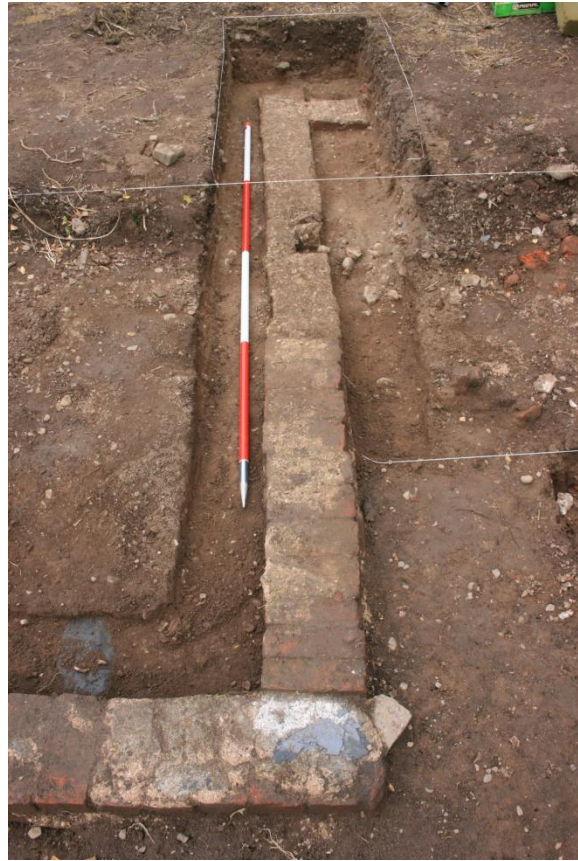
17, 18: The north wall (330) of the east wing with the junction with the east wall (332) exposed

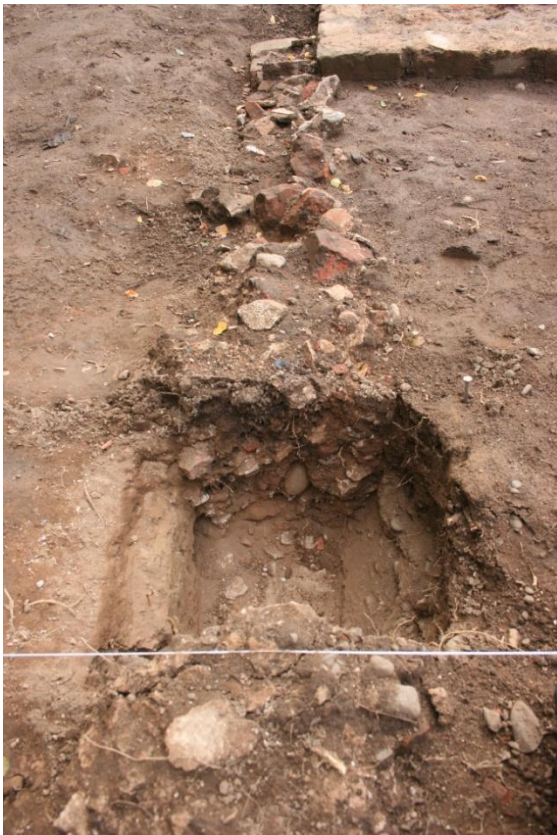
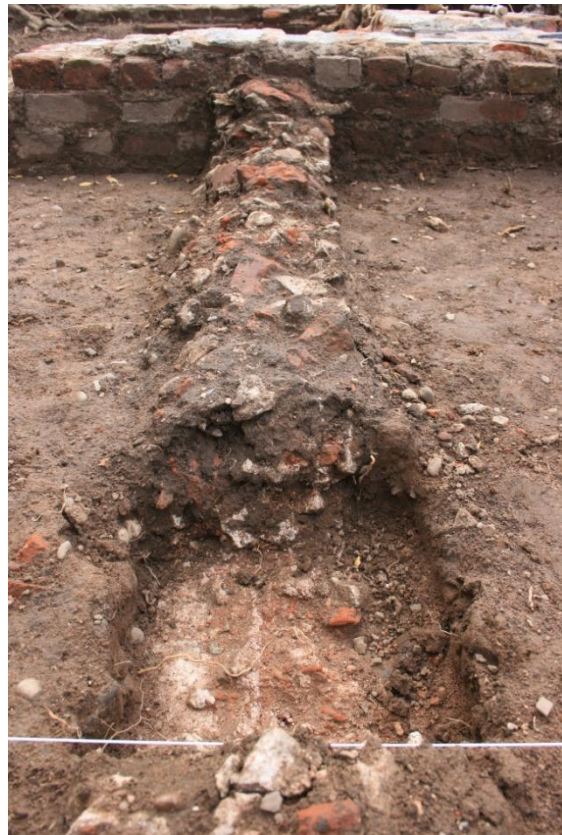
19, 20: East wing wall-trench sections: south/external wall 314 left, wall 316, right

Where these walls had been robbed out leaving rubble-filled trenches, a section was excavated across each to record its profile and any information that could be gleaned on the former superstructure of the wings from the rubble contained in the backfilled trenches. In the east wing, wall 312 was represented by a robber trench surviving to a depth of 40cms down to a flat mortar bottom; wall 316 was robbed to its flat base at a depth of 45cms though an additional 20cm-depth of the robber-trench stood above the surrounding machined level; the trench on the line of wall 314 survived to a depth of 35cms. All of these test-sections produced well broken-up brick rubble and mortar, together with pieces of mortar or plaster much whiter in colour than the standard buff lime mortar seen throughout the building. Some of the mortar or plaster had brick impressions, suggesting that it had been applied direct to brickwork rather than laid over battens and laths as was the case in the primary square building. The character of this white material (sampled) requires further investigation.

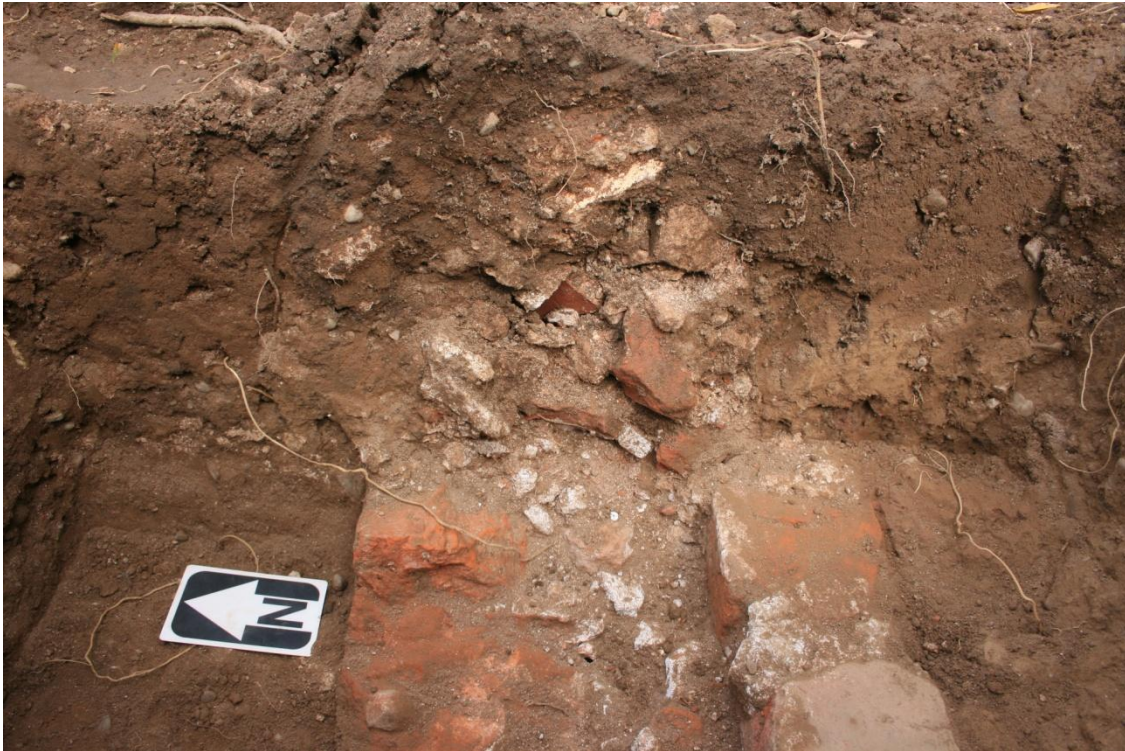
21. West wing: south/external wall 324, section looking east, showing extra external base-course of brick on the right, half buried by soils (305), and trail of mortar at the same level, left, inside, buried by soil (327). Note very white mortar between bricks and as rubble in the robber-trench fill

In the west wing, a section across the 'back' (south) wall 324 showed that the wall had been built with a wider, three parallel bricks-wide, base course, for which there was no cut from above: this had evidently been covered over by the subsequent deposition of soil on both sides. This was recorded in the east-facing section and confirmed by the west-facing section which showed the level off which the wall was built, marked by a trail of mortar, clearly buried under the surrounding soil (327). As walls 330 and 322 had surviving brickwork, these were not sectioned, but as wall 320 had been robbed out, this was sectioned: it again showed an extra base course buried by the surrounding soil (327). The implication is clearly that, on the west side of the square building, the walls or wall-footings of the west wing or west room had been built, and then soil dumped on that part of the site to raise the level. Assuming this was done to cover the base of the stone cladding on its slate bedding, this implies a depth of around 0.75m of re-deposited soil.

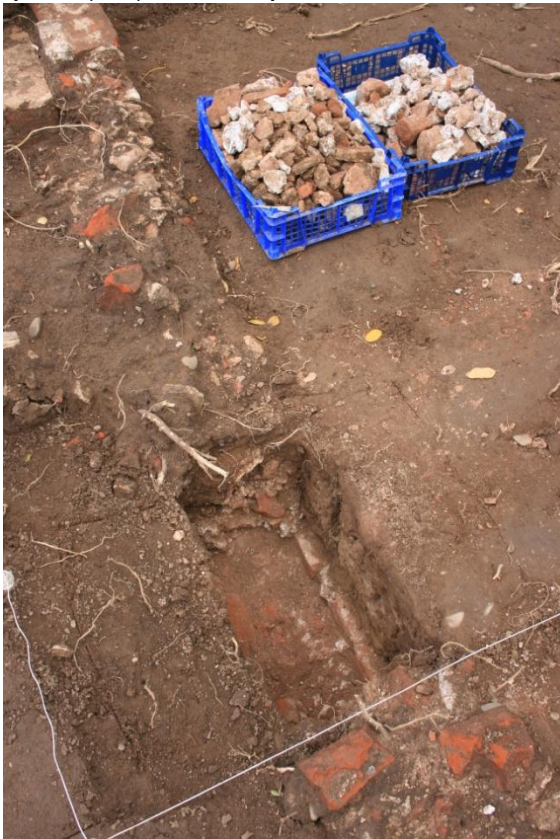
22. West wing, south/external wall 324, under excavation, showing part-buried external base course and the character of the rubble retrieved from the robber trench. Looking east.

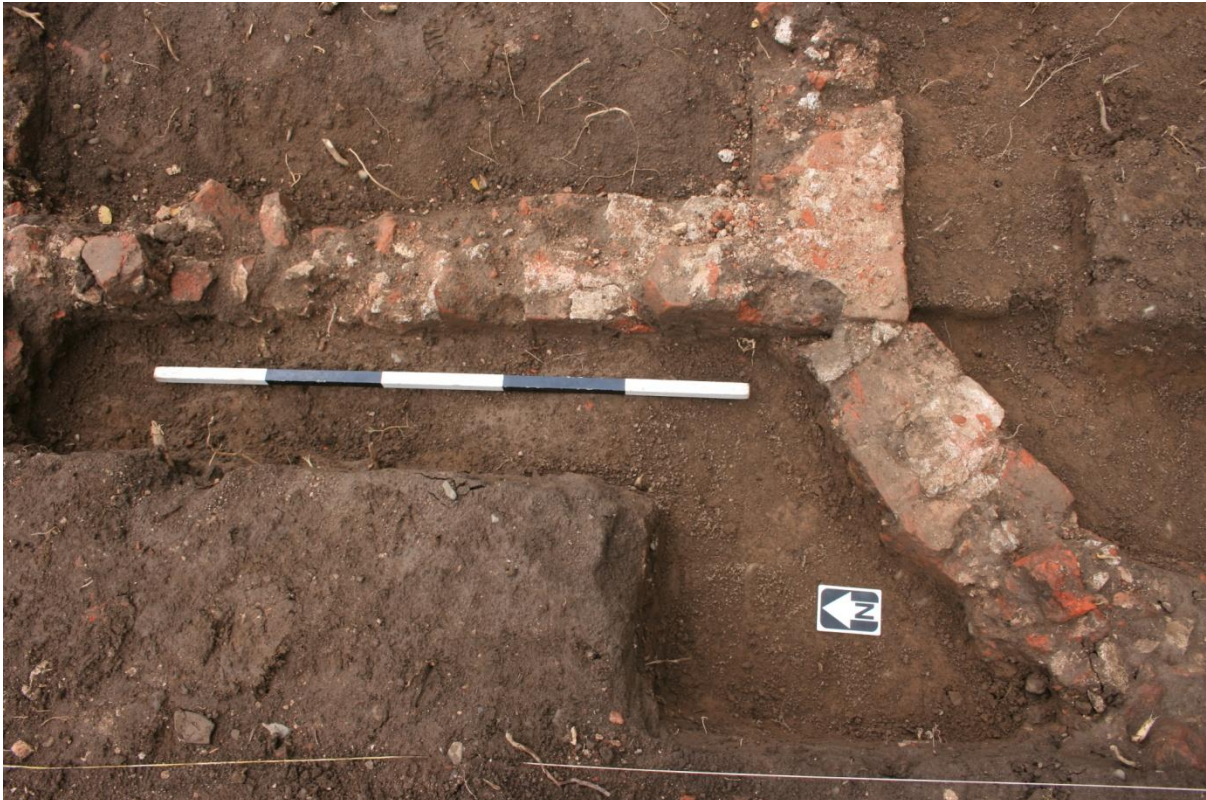
23. West wing, south-west corner, junction of walls 331 (centre), 324 (top) and abutting diagonal foundation 341

At the south-west corner of the west wing, a mortared brick footing was revealed at 45-degrees to the corner, not quite joined to it. It could not be determined whether this was the (not very good) footing for a corner-buttress, or the beginning of an additional wall joining the building to its enclosure/perimeter wall to the south (see below).

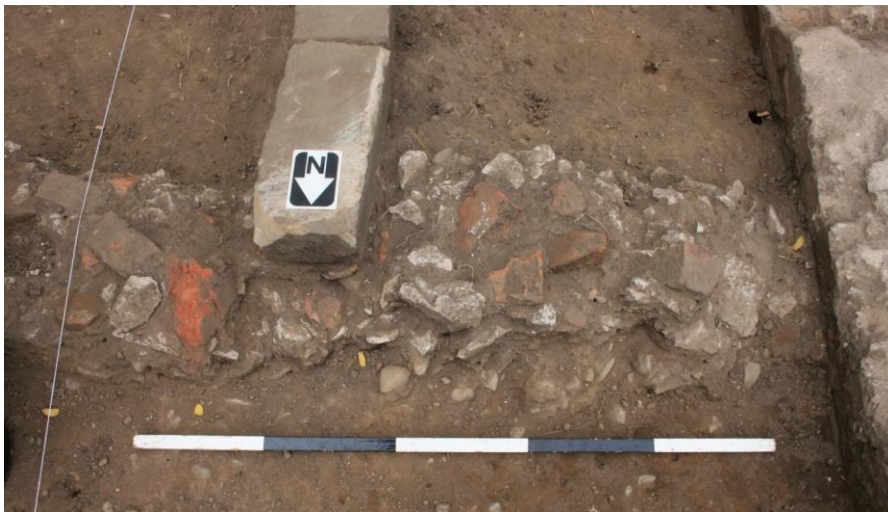
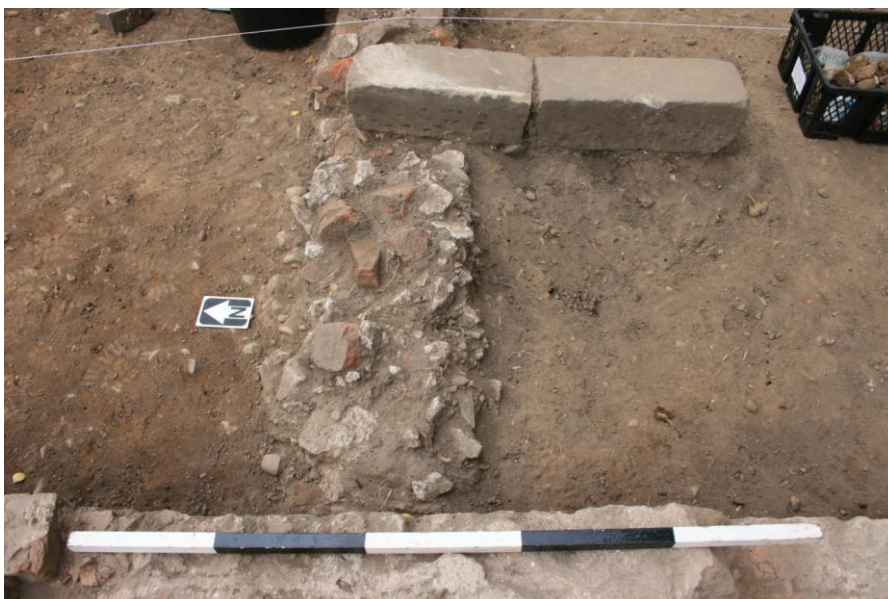
24, 25: The east side of the square building. Two views of sandstone 'veranda' wall 329 overlying the robber-trench of wall 316, running up to the main east wall 335

Two walls or wall-footings composed of a single course of long, grey (probably Grinshill) sandstone blocks, 16cms square in section by up to 43cms long, were recorded around the north and east sides of the square building. On the north side, this wall (328) was founded on the outside edge of the brick wall footing 330 at a distance of 0.7m out from the main north wall (333). On the east side, two identical in-situ blocks formed wall 329, also 0.7m out from the main east wall (335). These blocks, however, were not founded on underlying brickwork but were placed, without footings, on the unexcavated subsoil-like deposit cut by the robber-trench for the southern internal wall of the east 'wing', 316. The blocks of this wall were clearly stratified over the robber trench 316, showing that the latter wall had been dismantled and its brickwork grubbed out before the new sandstone-block footing was put in place across it. Two further blocks of wall 329 were observed further north on the same line during the initial machine clearance of the site in June. However, these were displaced by the JCB before they could be recorded (they can be seen in their displaced positions on the June photographs of site 3 – Baker 2018) but there is no doubt that they continued the line of wall 329 northwards, across and stratified over the east-west robber trench 312, to make a junction with the north-side wall 328.

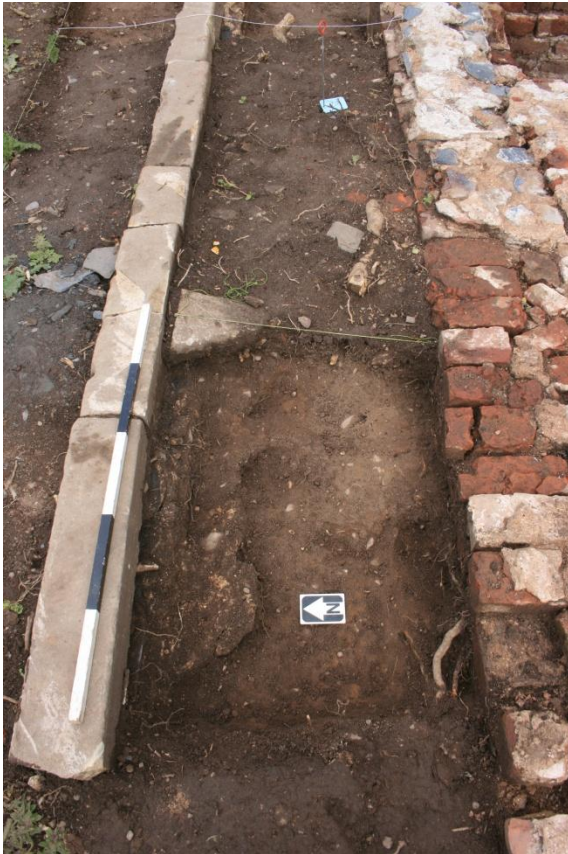
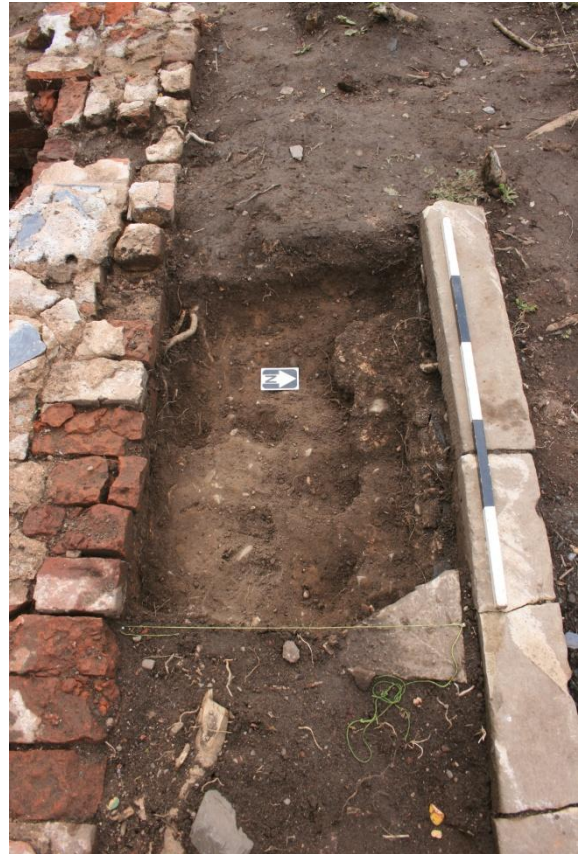
26, 27: The north (front) stone-block 'veranda' wall 328 overlying a bed of mortar above wall 330: left, looking east; right, looking west.

There was no sign of mortar bedding or scarring on the upper faces of these sandstone blocks – they do not seem to have formed a base course for a solid masonry wall. Instead, they are interpreted as sills supporting horizontal timbers – either the sole-plates for a timber-framed wall or, arguably more likely, the base for an open-sided, floored, timber structure such as a portico or veranda. The contrast between the solidly-founded brick

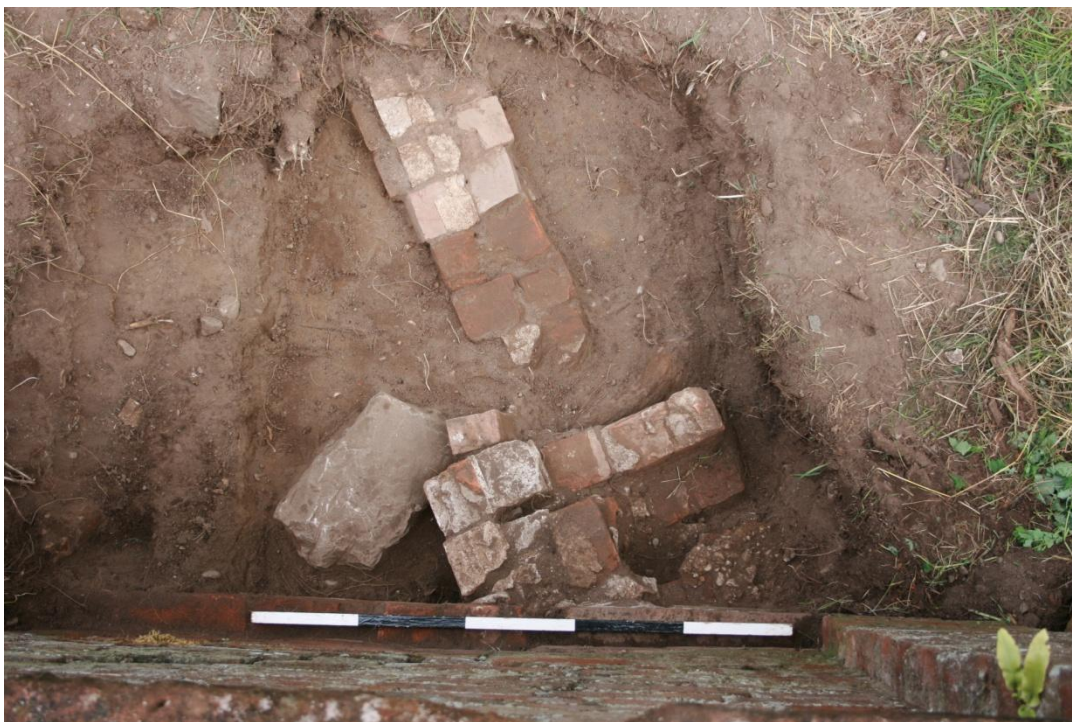
28. The wall junction trench (T4), north to left. The summerhouse enclosure wall ending at a (demolished) acute-angled return wall terminating the standing field boundary wall

It had previously been noted that the standing north-south brick boundary wall at the west end of the strip of cleared woodland was composed of the same size bricks. A trench (ATT 18 T4) was therefore opened immediately north of the gate at the end of Acacia Avenue, at the predicted junction of the excavated boundary wall and the standing wall to examine their relationship. Although the junction had been disturbed by the insertion of the gate, enough survived to show that the two walls were indeed contemporary, their courses running through and properly bonded. The excavation also showed that the present field boundary wall had originally terminated with a very short return wall at an acute angle, on the line of the excavated boundary wall. This feature had later been removed to below present ground level, either when the enclosure wall was demolished and robbed, or when the present gateway was inserted in the field wall for Acacia Avenue in the mid-20th century.

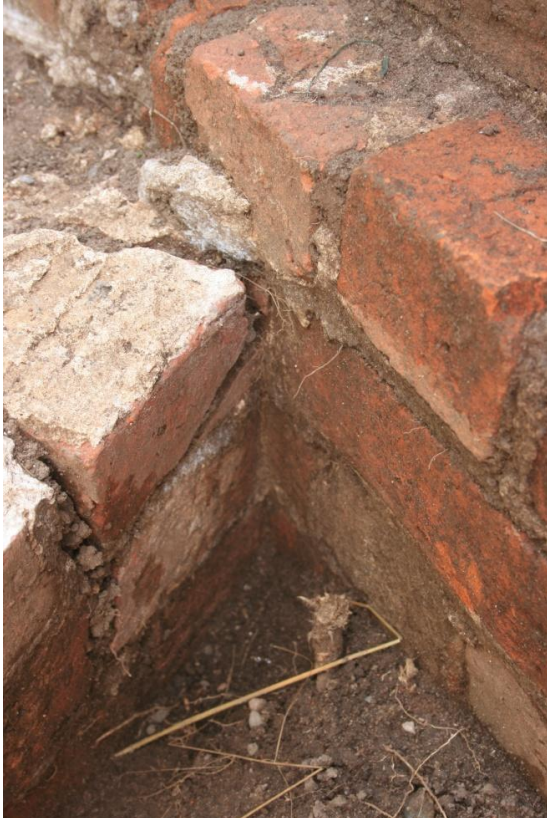
29. The brickwork at the junction of the summerhouse enclosure wall (left) with the angled return to the field boundary wall (right): the two walls have continuous coursing and appear to be contemporary

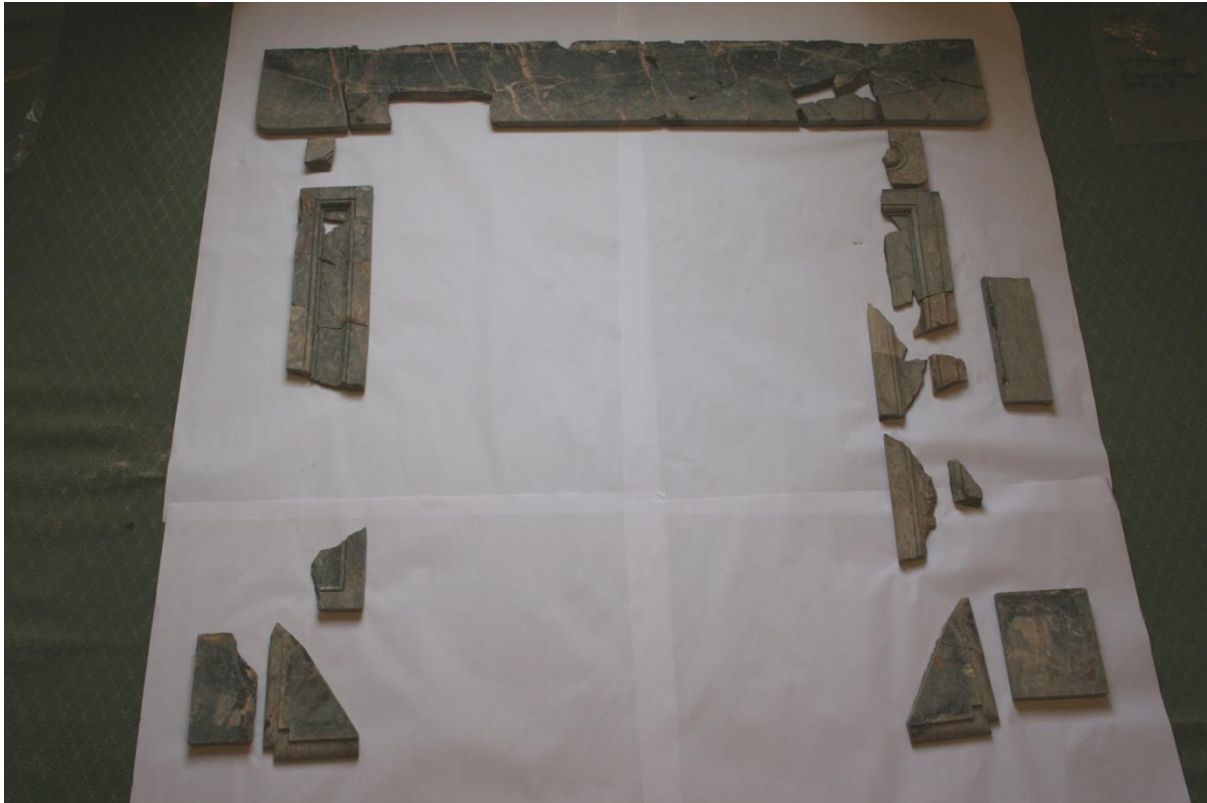
33. The fireplace reconstructed

Many pieces of black fossiliferous, white- or red-veined, polished, Purbeck marble were present, and these represented the remains of a destroyed fireplace. The mantelpiece was reconstructed, and was found to be about 95% complete. It was about an inch thick with curved corners, straight unmoulded edges, and was 1.457m long (4ft 9.25 ins) and would have projected 18cms from the wall face above. The left-hand end of the mantelpiece bore a graffiti inscription '*I Thomas Truman*' in a cursive script, lightly scratched with a sharp point. This is discussed further below (see fig.49).

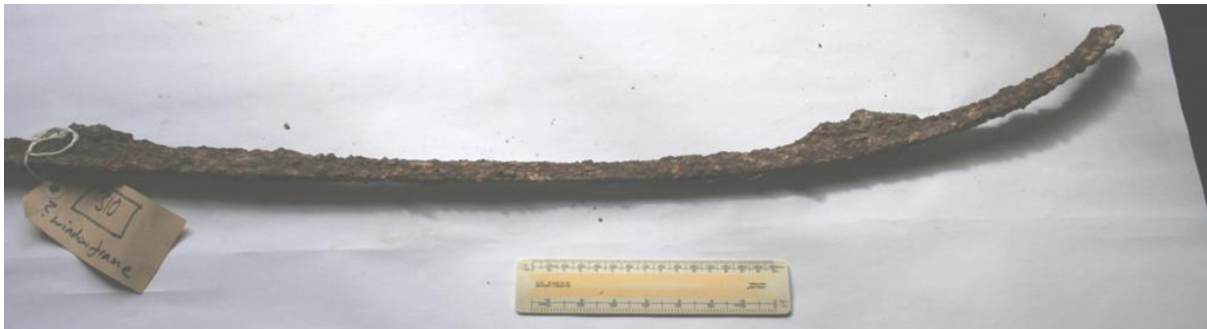
34. Possible window-frame fragment (context 310 – NE quadrant of square building)

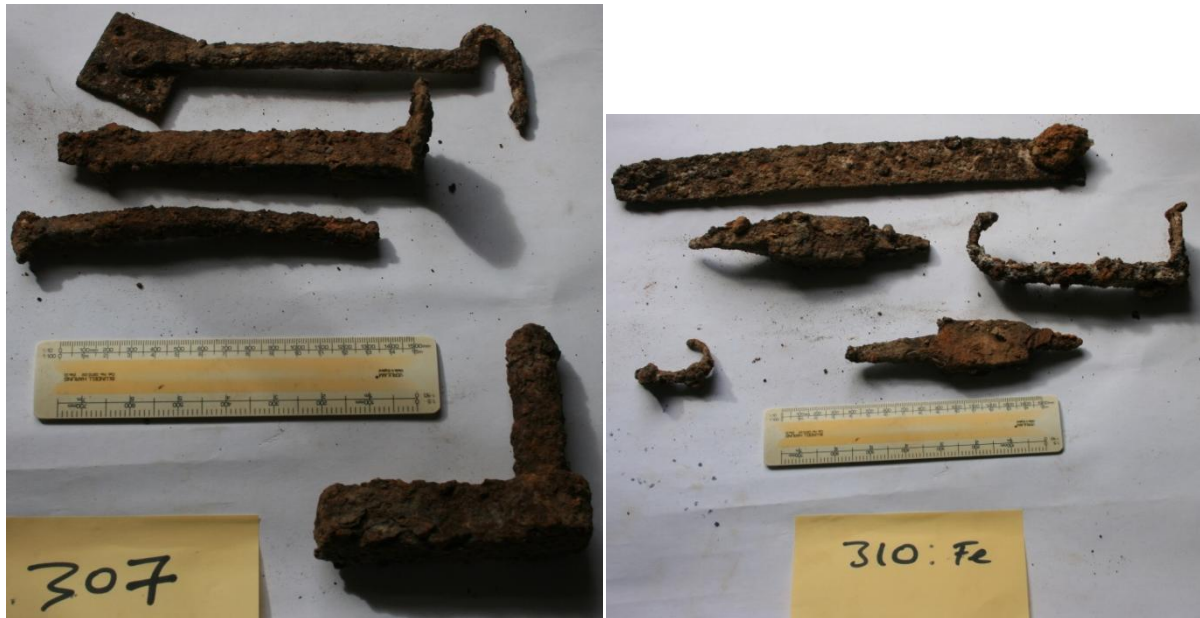
38, 39: Ironwork from the main demolition deposits

Ironwork from the site was dominated by hand-made iron nails of varying length but included a shutter-latch, a pair of hinge pintels from a heavy door and a number of objects that need identification but appear to be clamps for securing the external stone cladding.

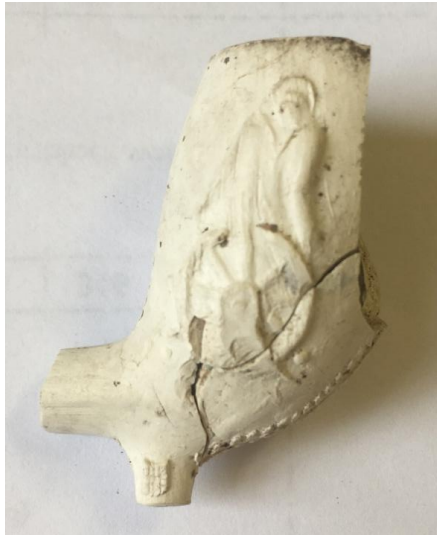
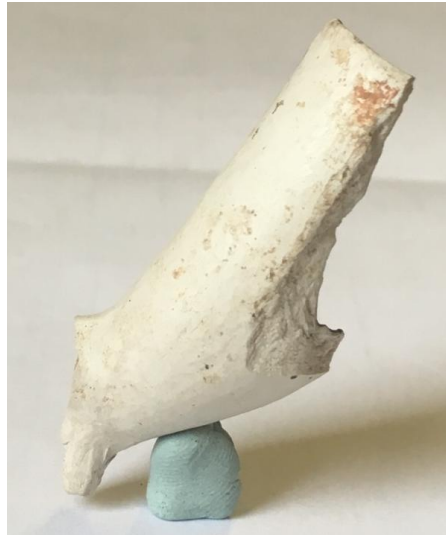
40, 41: the excavated clay-pipe bowls

Two clay pipe bowls were found but require expert identification. One bears a moulded decoration of a sailor and a ship's wheel and appears to be early 19th-century. A second bowl with a spur again appears (to a non-specialist) to be late 18th or 19th-century. Both were recovered from the sub-floor space.

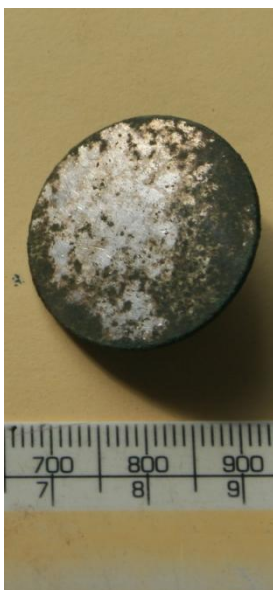
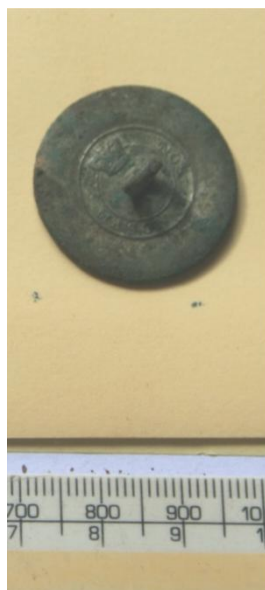
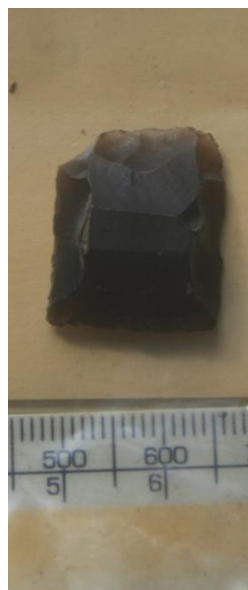
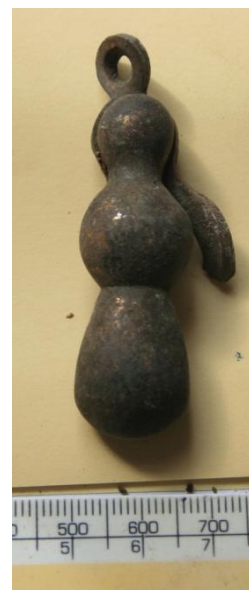
42-45 Left and centre: button from 307; centre-right pistol-flint from 303 (outside east wall); right: key-hole cover (laquered brass?)

A few non-ceramic non-ferrous objects of significance were found. A button found on the base of the sub-floor space (context 307) could have been deposited either when the building was first built, or when the floor had been taken up on its demolition. This was of copper alloy (brass), silver-plated or gilded on the front, with a maker's name stamped on the back. This was identified during the excavation by Simon Walker, who found the manufacturer's name, Richard Mason, in a trade directory of 1830, listed as a button-maker at 110 Lionel Street (West, M, 1830, *The history, topography and directory of Warwickshire*, p.363). A gun-flint, identifiable from its smaller size as a pistol flint (with thanks to Peter Wright), was found in topsoil context 303 outside the east wall of the square building, and presumably pre-dates the 1840s when percussion weapons entered general military and sporting use. A brass key-hole cover is of a type found throughout the mansion.

fallen plaster), and the nature of the structure – a sub-floor space – would have excluded objects from the building's use. The pottery appeared to the excavators to be broadly consistent with an 18th or early 19th century date. The button from the demolition deposit 307 was identified as being of broadly c.1830 from its maker's appearance in a directory of that year, but could of course have been made well before that date, or after, or could have been old when dropped. The pistol gun flint from the topsoil east on the east side of the building is indicative of the period before the 1840s. The clay pipes await identification but appear broadly to belong to this period too.

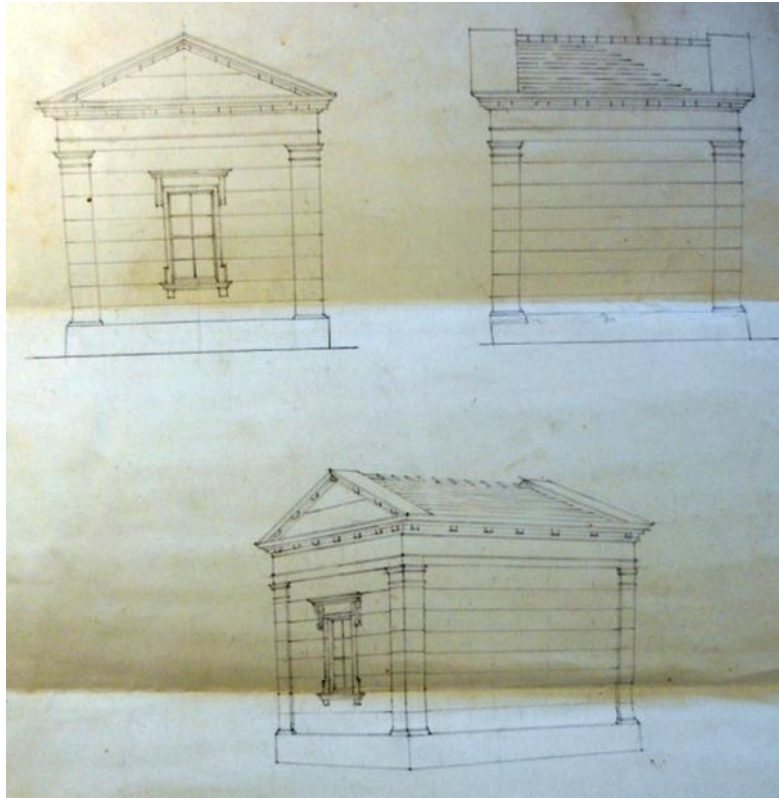
50. 1909 drawing of the (more expensive) proposed pump house using the cornice and masonry recycled from the 'summerhouse in the woods' (original: Shropshire Archives; reproduction taken from Kevin Triggs' *Attingham Water 1898-1945*)

Water 1898-1945, p.2, quoting SA 112/7b3/2/3/5). The letter was accompanied by two drawings, one of a simple square, masonry, pyramidal-roofed building, the other of a more elaborate building in neoclassical form with pedimented gables and an overhanging cornice. This appears to represent the more expensive option being quoted for 'using up the old cornice'. (fig.50)
