An early 19th-century summerhouse
in Attingham Park, Shropshire:
an interim excavation report

Nigel Baker
October 2018
(2nd edition May 2019)

SUMMARY

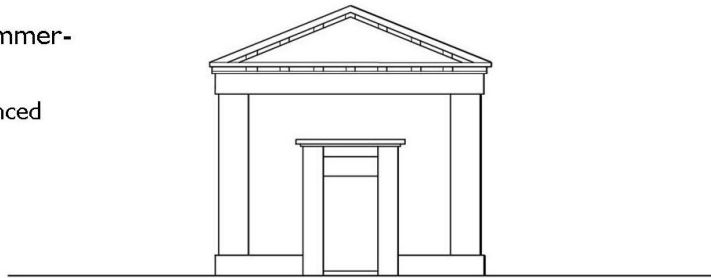
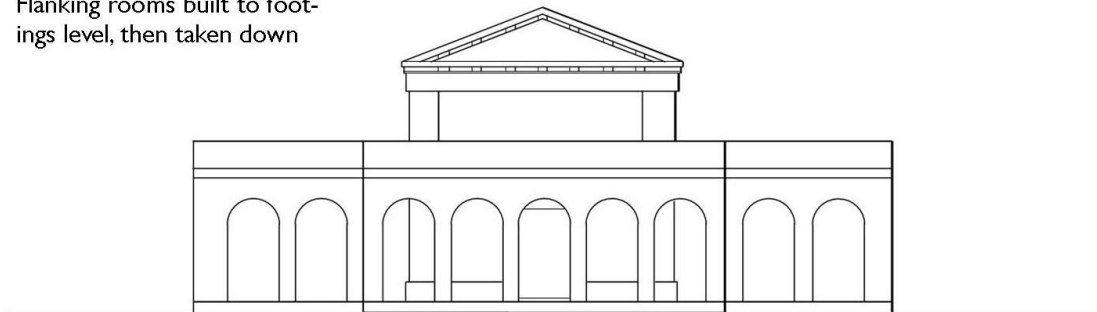
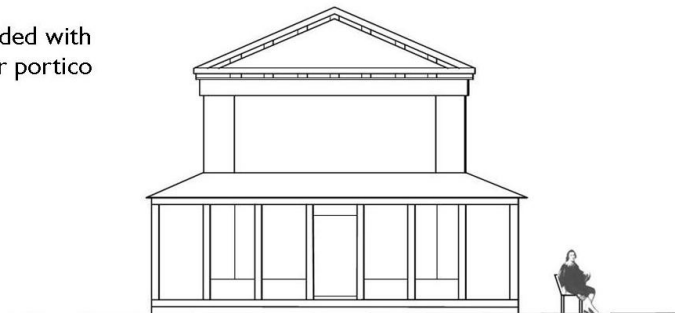
2. 'The Lodge'

Redesigned with flanking rooms and raised in height. Flanking rooms built to footings level, then taken down

3. The second summer-house

Completed. Provided with lightweight timber portico
